Boosting First-Pass Yield

Laser-based inspection of solder paste deposits and component placement can dramatically improve first-pass yield.

■ **By Stacey Wagner**
Senior Process Engineer
Kimball Electronics Group
Auburn, IN

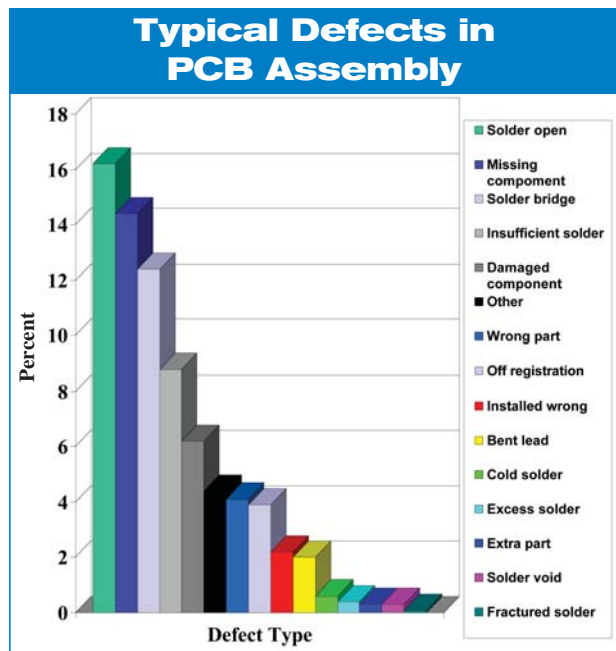
Nearly 40 percent of all printed circuit board defects are component-related, such as bent leads and misaligned components.

In-line inspection during surface mount assembly has become increasingly necessary as components shrink, boards get smaller and more complex, and profit margins narrow. Nearly 40 percent of all printed circuit board (PCB) defects are component-related, such as bent leads, missing components and misaligned components. By inspecting boards before reflow, assemblers can lower rework costs and improve process control.

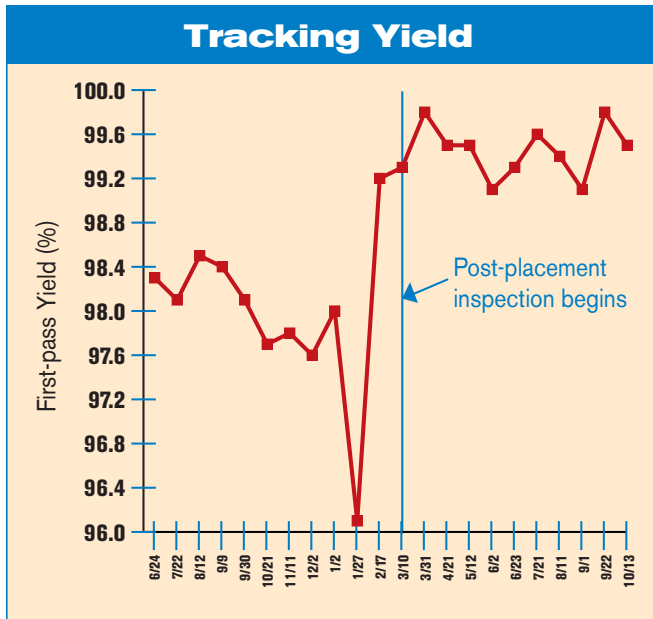
Since Kimball Electronics began inspecting populated boards prior to reflow, first-pass yields have consistently exceeded 99 percent.

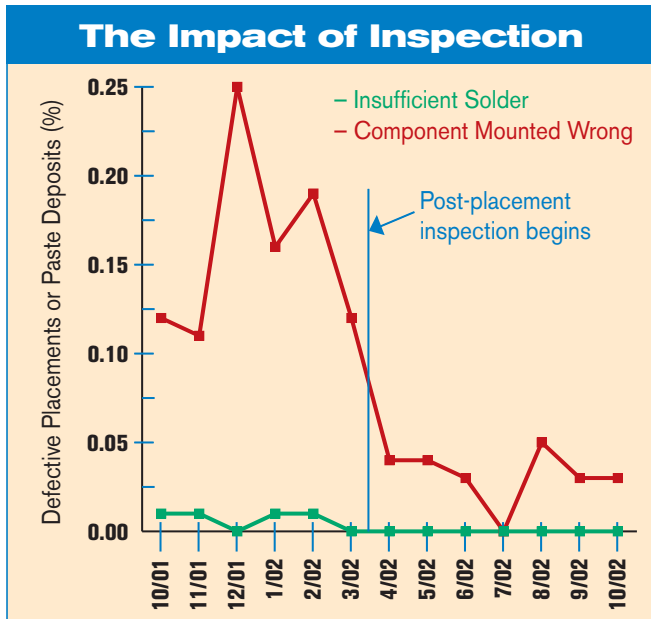
Component placement inspection dramatically reduced the number of mismounted components at Kimball Electronics.
